**Flood Control Project Maintenance
Levee Inspections**

Fall 2010 Levee Maintenance Deficiency Summary Report

San Joaquin River Basin

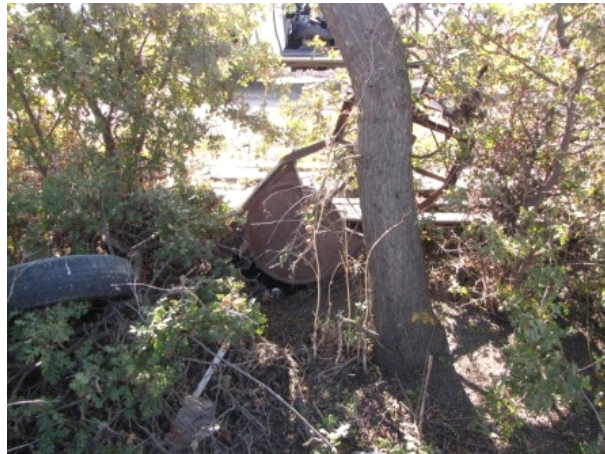
Levee Mile Report Line	9
Start Levee Mile	1.00
End Levee Mile	1.00
Location	Water Side
Category	Interior Drainage & Piping Systems
Item	Sluice / Slide Gates

View of a slide gate that has been badly damaged and is unable to be closed on the waterward side of the levee.

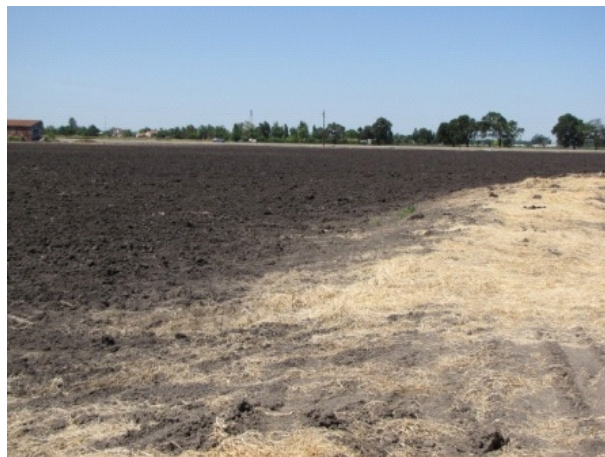
Levee Mile Report Line	13
Start Levee Mile	1.30
End Levee Mile	1.54
Location	Land Side
Category	Earthen Levee
Item	Encroachments

View of damage to the landward slope of the levee caused by the landowner driving a tractor over the levee looking downstream.

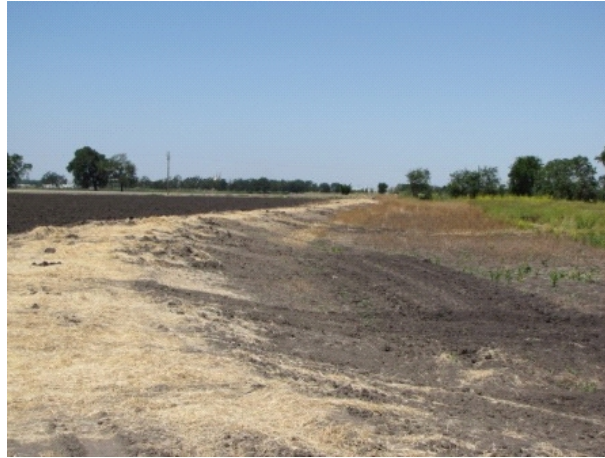
View of damage to the waterward slope of the levee caused by the landowner driving a tractor over the levee looking downstream.

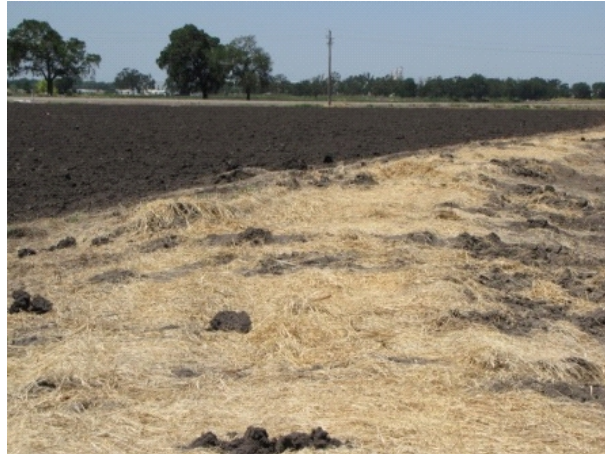
Levee Mile Report Line	15
Start Levee Mile	1.31
End Levee Mile	1.54
Location	Crown
Category	Earthen Levee
Item	Encroachments

View of damage to the crown of the levee caused by the landowner driving a tractor over the levee looking downstream.

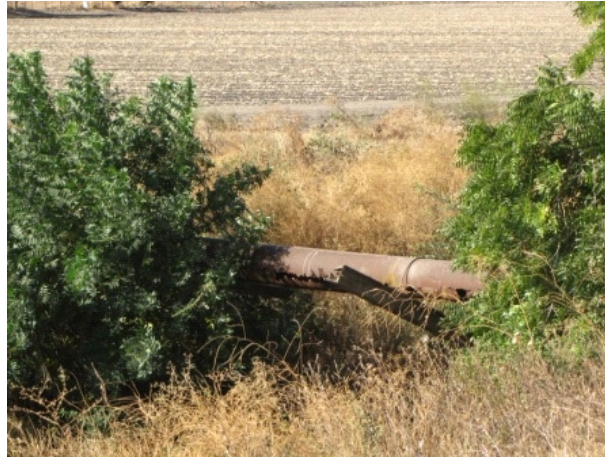
View of a pipe crossing the channel with severe corrosion.

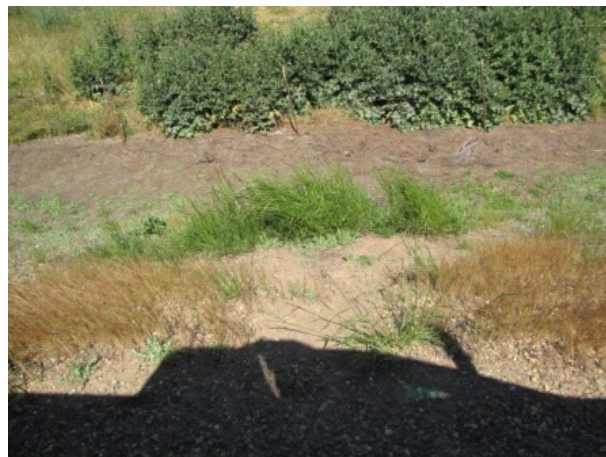
Levee Mile Report Line	72
Start Levee Mile	4.80
End Levee Mile	4.80
Location	Land Side
Category	Earthen Levee
Item	Erosion / Bank Caving

View of depression possibly caused by erosion in the landward slope.

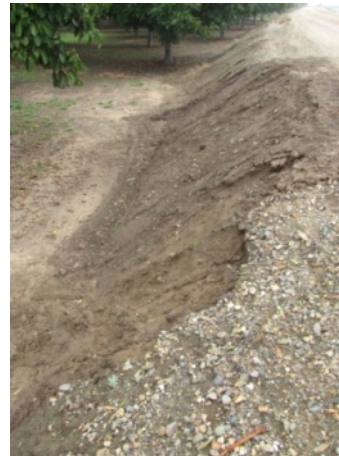
Levee Mile Report Line	94
Start Levee Mile	9.95
End Levee Mile	9.95
Location	Land Side
Category	Earthen Levee
Item	Erosion / Bank Caving

View of erosion occurring on a recent slope repair on the landward slope looking upstream.

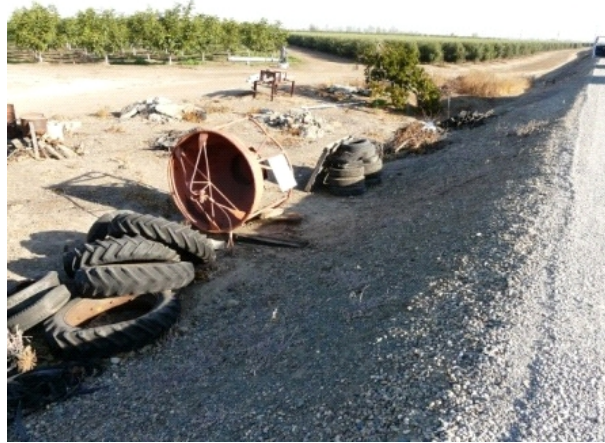
Levee Mile Report Line	108
Start Levee Mile	10.95
End Levee Mile	10.96
Location	Land Side
Category	Earthen Levee
Item	Encroachments
Debris located along landside toe of levee from LM 10.95 to LM 10.96.	
dpesaven_f_20100928_018.JPG

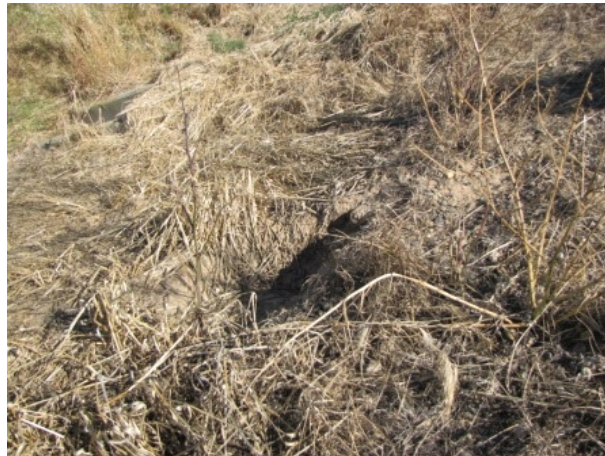
Levee Mile Report Line	112
Start Levee Mile	12.72
End Levee Mile	12.72
Location	Land Side
Category	Earthen Levee
Item	Erosion / Bank Caving
View of a depression possibly caused by erosion in the landward slope.	
dpesaven_f_20100928_027.jpg

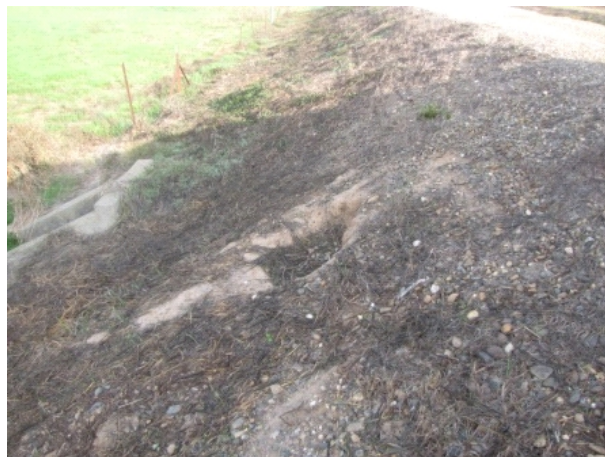
Levee Mile Report Line	112
Start Levee Mile	12.72
End Levee Mile	12.72
Location	Land Side
Category	Earthen Levee
Item	Erosion / Bank Caving
Updated view of the depression possibly caused by erosion as of fall 2010 looking upstream.	
dpesaven_f_20101105_520.jpg

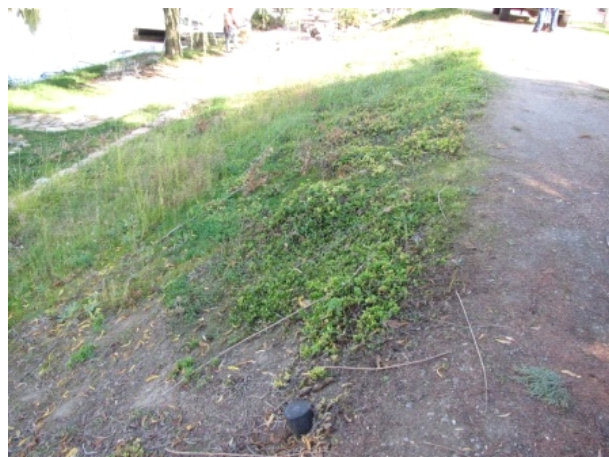
Levee Mile Report Line	19
Start Levee Mile	0.82
End Levee Mile	0.83
Location	Water Side
Category	Earthen Levee
Item	Encroachments
View of landscaping and irrigation on the waterward slope looking upstream.	
dpesaven_f_20100928_171.jpg

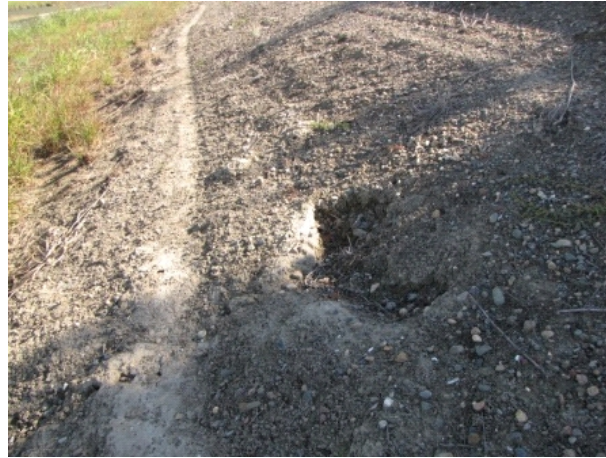
View of a depression likely caused by rodents in the waterward slope looking upstream.

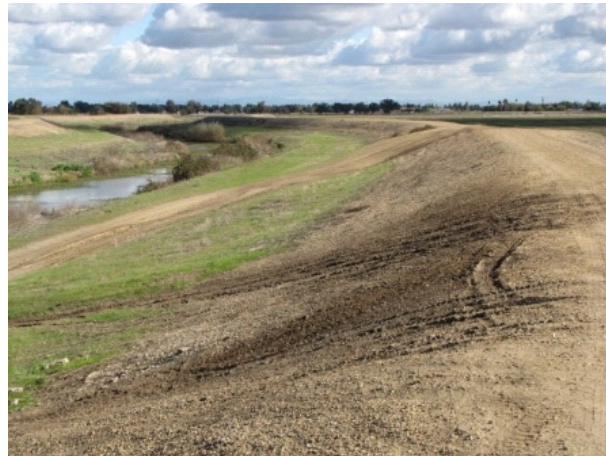
Levee Mile Report Line	129
Start Levee Mile	6.24
End Levee Mile	6.24
Location	Water Side
Category	Earthen Levee
Item	Slope Stability

View of damage to the waterward slope of the levee due to vehicle traffic looking upstream.

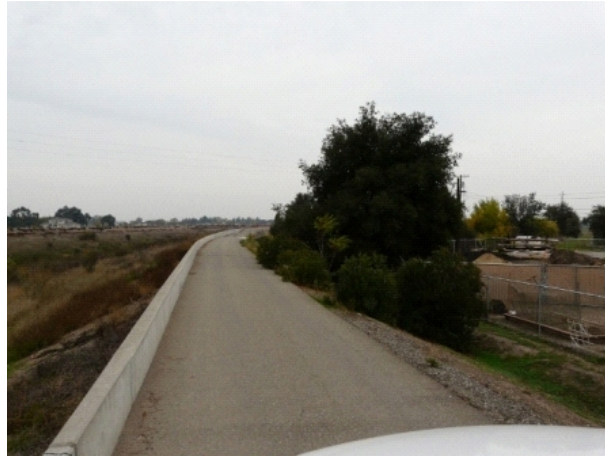
Levee Mile Report Line	133
Start Levee Mile	7.57
End Levee Mile	7.62
Location	Land Side
Category	Earthen Levee
Item	Encroachments
Landscaping along landside slope of levee from LM 7.57 to 7.62	
dpesaven_f_20100928_092.JPG

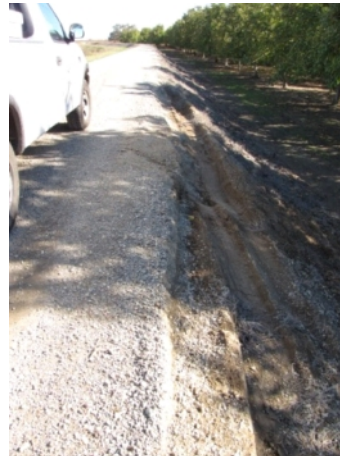
Levee Mile Report Line	137
Start Levee Mile	8.89
End Levee Mile	8.89
Location	Land Side
Category	Earthen Levee
Item	Slope Stability
View of the landward slope damaged by vehicular traffic looking upstream.	
dpesaven_f_20100928_193.jpg

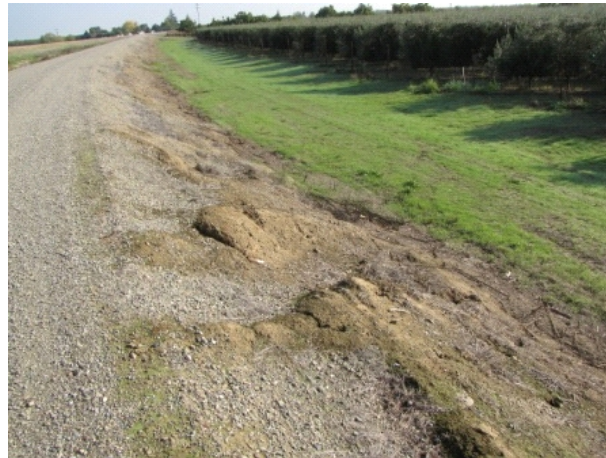
View of depressions and soil movement likely caused by erosion looking upstream.

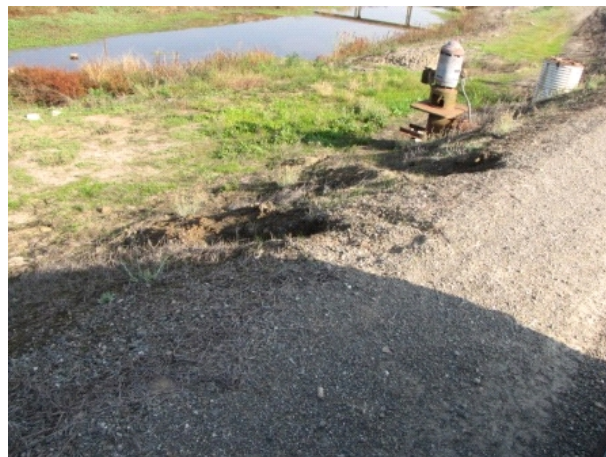
Levee Mile Report Line	164
Start Levee Mile	12.93
End Levee Mile	12.93
Location	Land Side
Category	Earthen Levee
Item	Slope Stability

View of rutting on the waterward slope likely caused by vehicle traffic looking upstream.

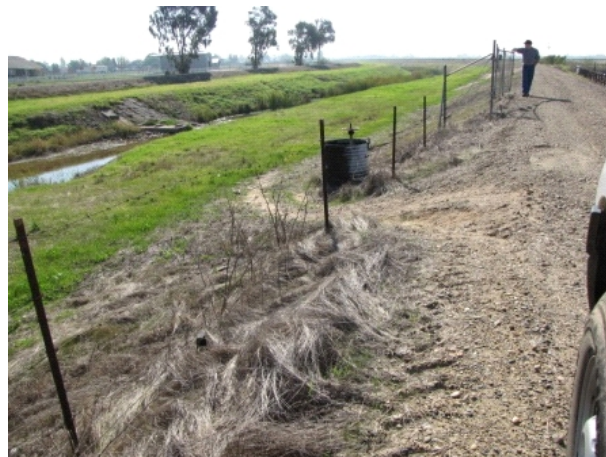
Levee Mile Report Line	7
Start Levee Mile	0.47
End Levee Mile	0.47
Location	Land Side
Category	Earthen Levee
Item	Slope Stability

View of damage to the waterward slope caused by pedestrian traffic looking downstream.

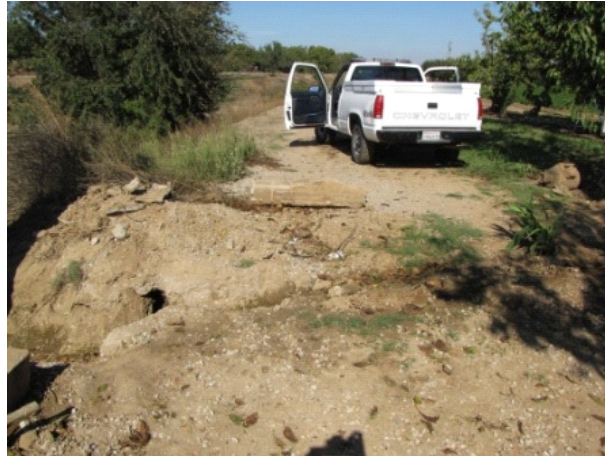
Levee Mile Report Line	18
Start Levee Mile	4.31
End Levee Mile	4.31
Location	Crown
Category	Earthen Levee
Item	Crown Surface / Depressions / Rutting
View of recent construction that has left the access road damaged looking upstream.	
dpesaven_f_20100928_366.jpg
